# SPECTRACOM NETCLOCK/2 RECEPTION

## SECTION 1: INTRODUCTION

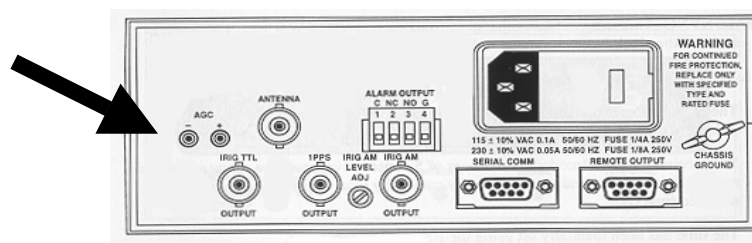
Connect a DC voltmeter to the rear panel AGC test points. Refer to Figure 3-1 below. The AGC voltage is approximately 2.3 VDC at a field strength of 100  $\mu$ V/meter using a properly-oriented Model 8219 Loop Antenna and Model 8207 Preamplifier.

**FIGURE 3-1.** AGC Test Point Location for Black Enclosure Netclock/2

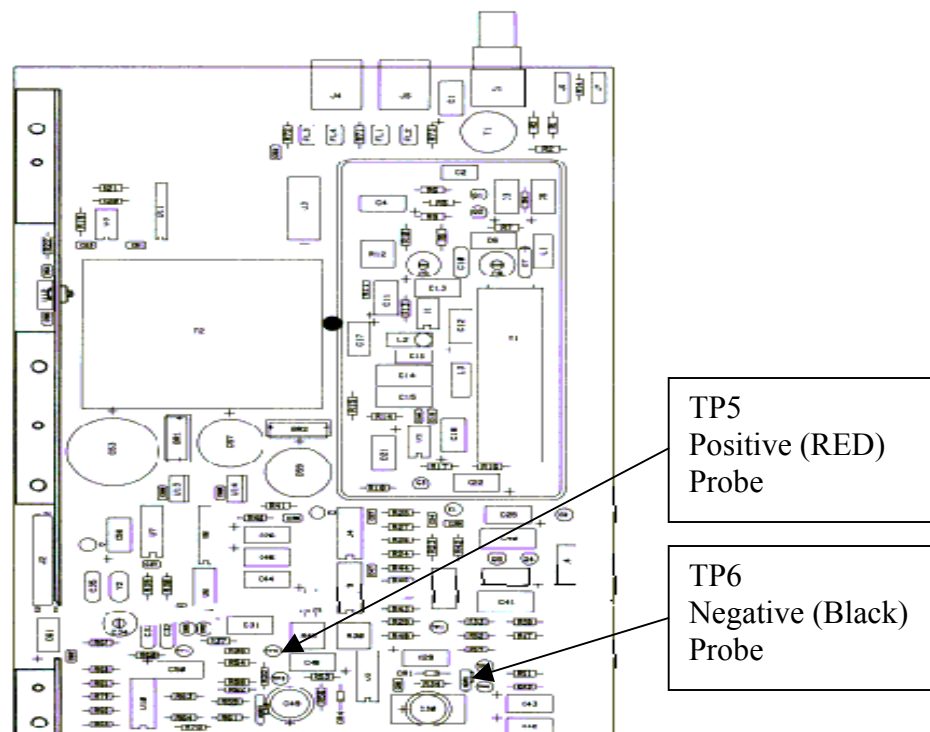
The top cover of the clock needs to be removed to access the AGC test points located on the receiver board. Refer to Figure 3-2 below. Turn the clock upside down and remove the two indented screws that hold the bottom cover to the top cover. Turn the clock back upright and carefully remove the top cover. Connect a DC voltmeter to the AGC test points. The AGC test points are located on the top PC board. The Black probe should go to TP 3, and the red probe should go to TP 5. The AGC voltage is approximately 2.3 VDC at a field strength of 100  $\mu$ V/meter using a properly-oriented Model 8219 Loop Antenna and Model 8207 Preamplifier.

**FIGURE 3-2.** AGC Test Point Location for Beige Enclosure Netclock/2

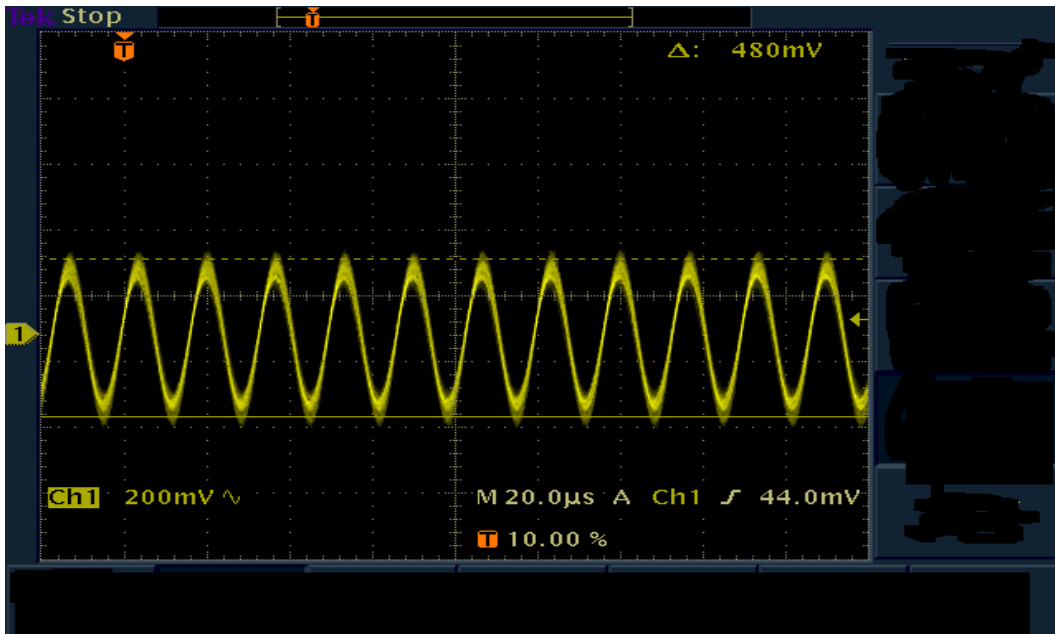
If an oscilloscope is available, there is a test point on the RF amplifier output, inside the Netclock/2 that allows the WWVB carrier signal to be viewed. Viewing the WWVB carrier with an oscilloscope can help define if noise or saturation is present. Connect the oscilloscope probe to TP E1 located just in front of the metal shield on the top board. Connect the probe ground to TP E2 located just to the right of TP E1. Figure 5-1 below is an example of good reception. The signal is decreased in amplitude once a second for a set duration depending on the data bit being sent. Figure 5-2 is an example of poor reception. The peaks are filled in, making the signal look like a ribbon cable. Refer to *Section 5.1.1, Signal Evaluation* for determining signal quality.

**FIGURE 5-1.** Example of Good Reception

#### **Indications of good reception:** (Refer to Figure 5-1)

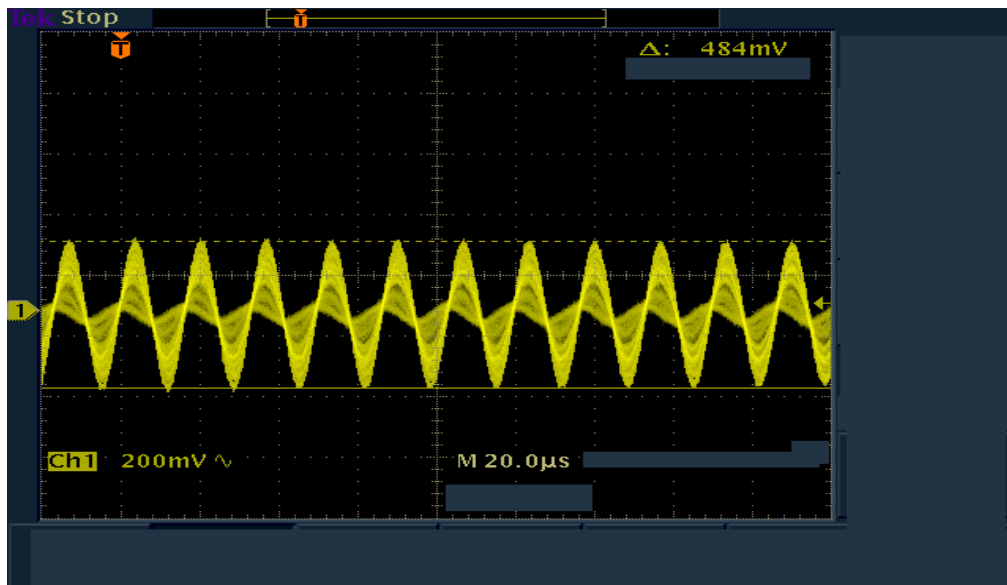
**Figure 5-2.** Example of Poor Reception

#### **Indications of noise or saturation at the site:** (Refer to Figure 5-2)
